Septic System Compliance Inspection – Existing System

DATE 5/23/2023

Property Owner: John McIntosh Street Address: 44228 348th Lane City, State, Zip: Aitkin, MN 56431

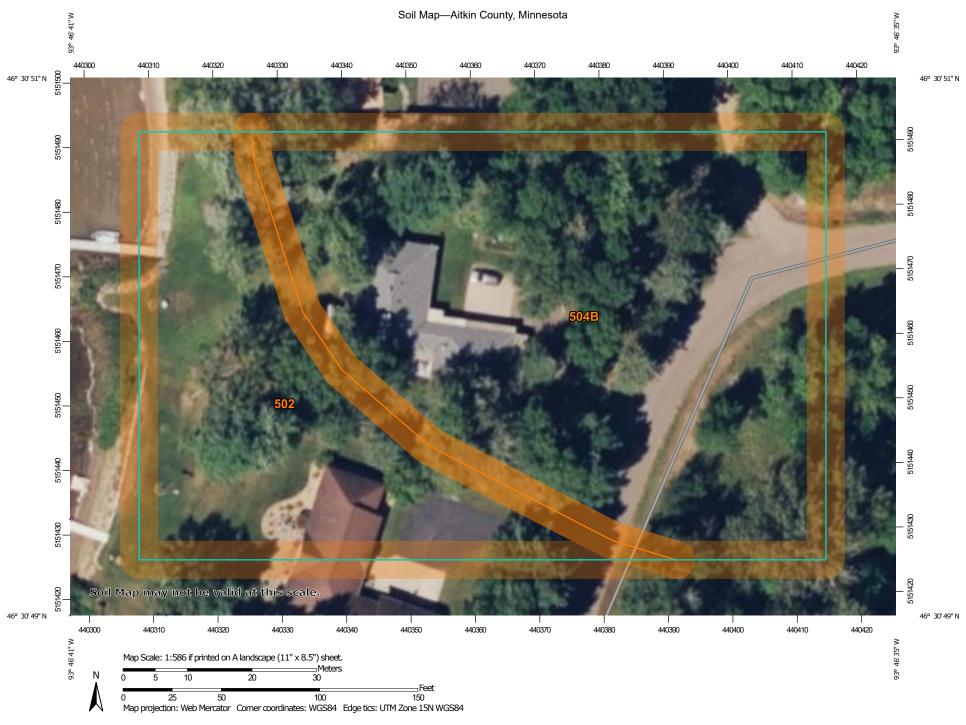
Map Unit Symbol	Map Unit Name	Acres in AOI	Percent of AOI
502	Dusler silt loam	0.6	33.9%
504B	Duluth fine sandy loam, 1 to 6 percent slopes	1.2	66.1%
Totals for Area of Interest	•	1.8	100.0%
