Culvert & Easement repair off Peony Ave. (SW side of Taylor Lake)

Culvert & Easement road repair:

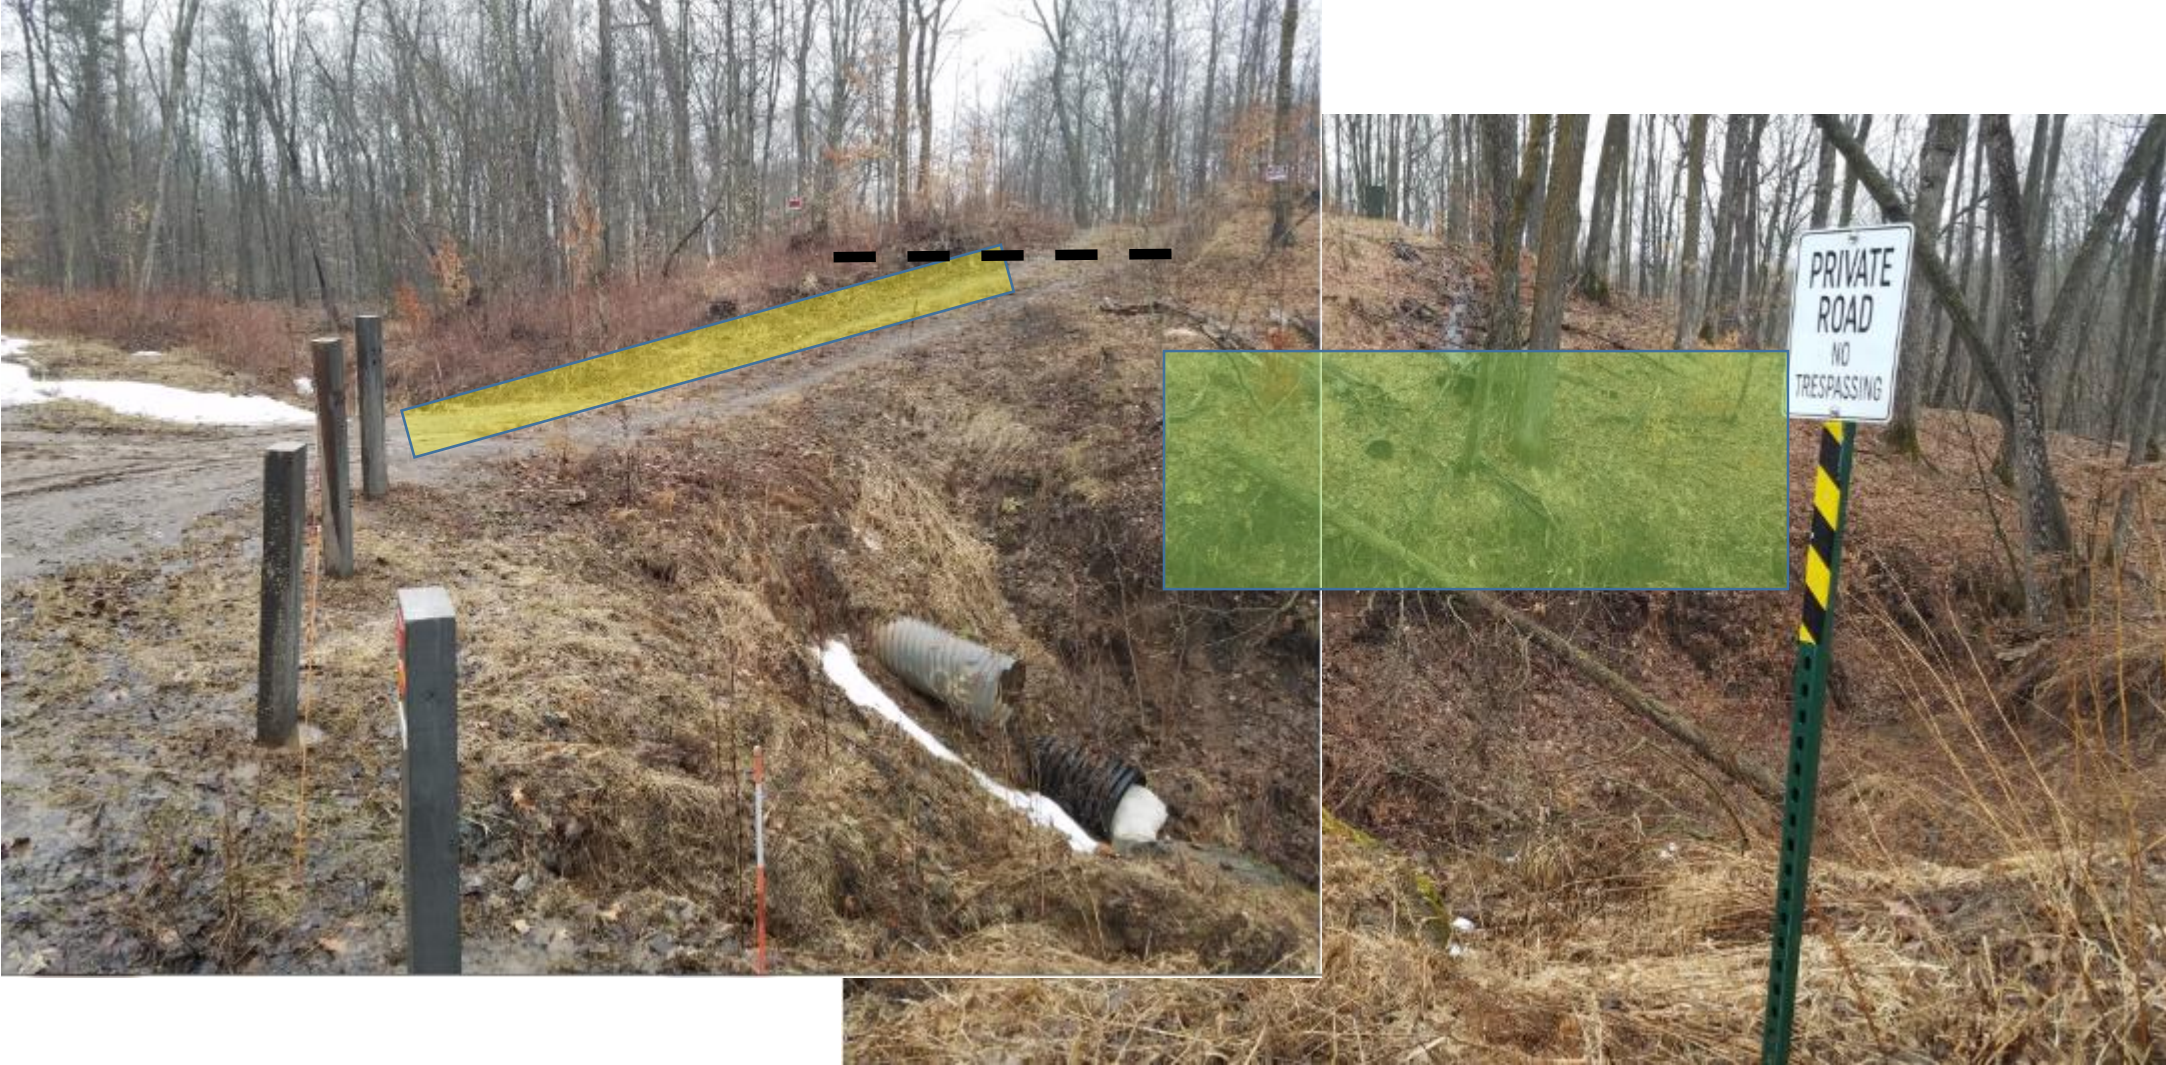
Scrape 10-15 yds off the top of the hill down to this line, fill used in washout area.

Widen the road on this side to allow safer access and keep vehicles away from drainage area.

No intended digging in this area, intent is to leave as is, seed grass and some bushes to solidify hill

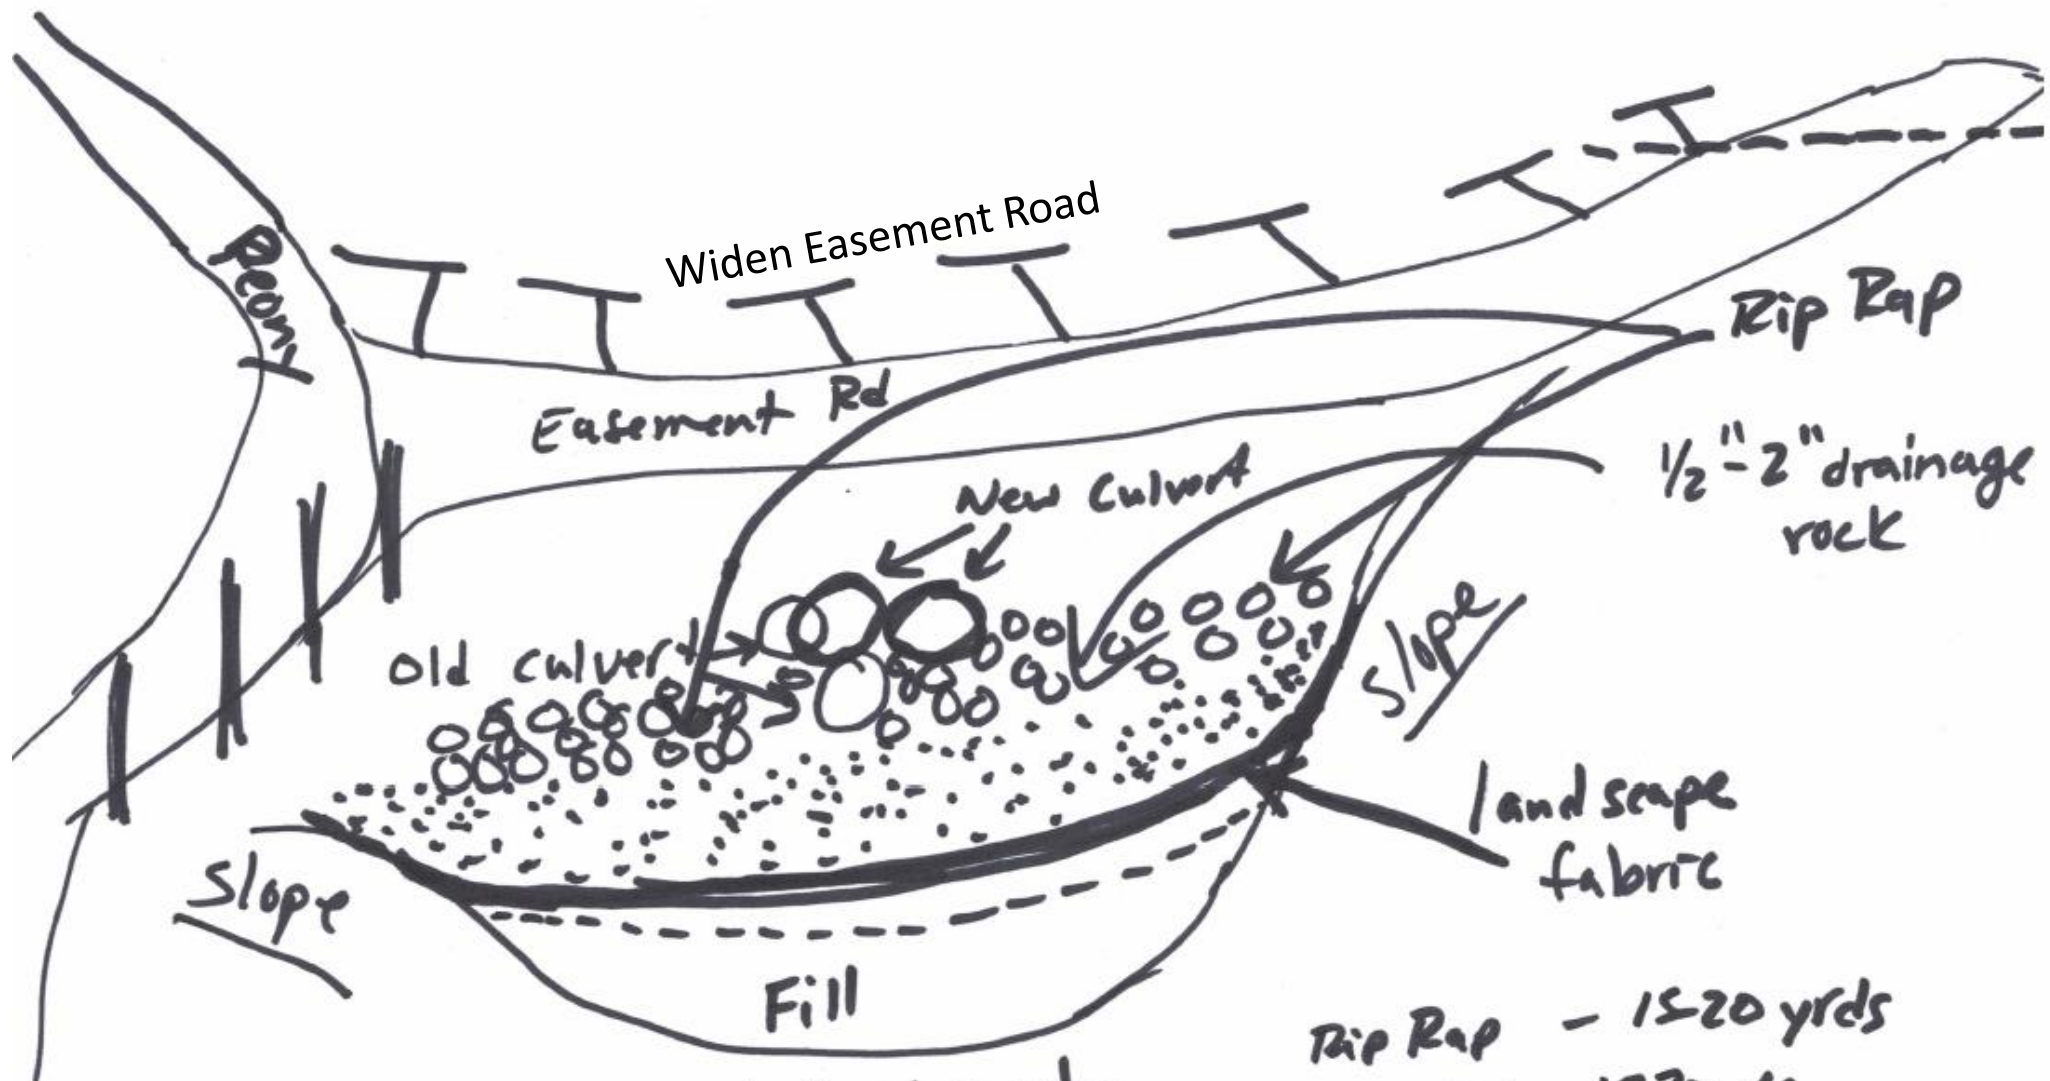
- Rip Rap - 15-20 yds
- Drainage Rock - 15-20 yds
- Fill - 15-20 yds
