Emerson, Kevin  
Hammal Lake

Land Alteration App. # App-2022-009154, UID # 205782

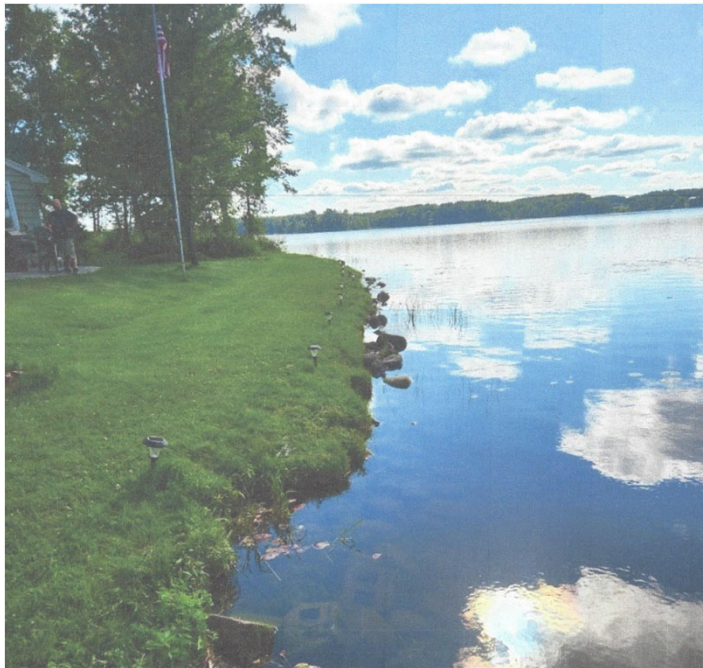
Pre-existing conditions per photo attached to application

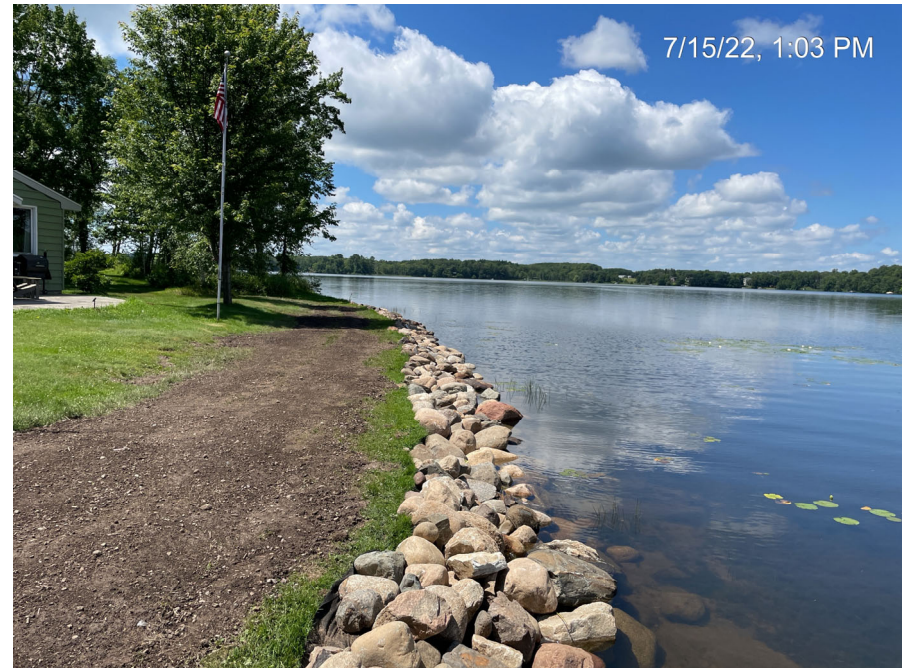
- Submitted on 7/7/22
- Inspected on 7/15/22
  - Rip-rap was already installed
  - No erosion control after construction disturbance
  - Some rip-rap appears to be below OHW which DNR doesn't require a permit
  - With rip-rap being installed prior to an onsite inspection Henry could not determine if an active erosion problem existed
  - Would require a vegetative buffer to be established with issuance of any land alteration rip-rap permit

Onsite inspection photo 7/15/22
